PV Solar Project Evaluation Procedure and Case Study

409 KW CASE STUDY: CALIFORNIA PV SOLAR PROJECT EVALUATION

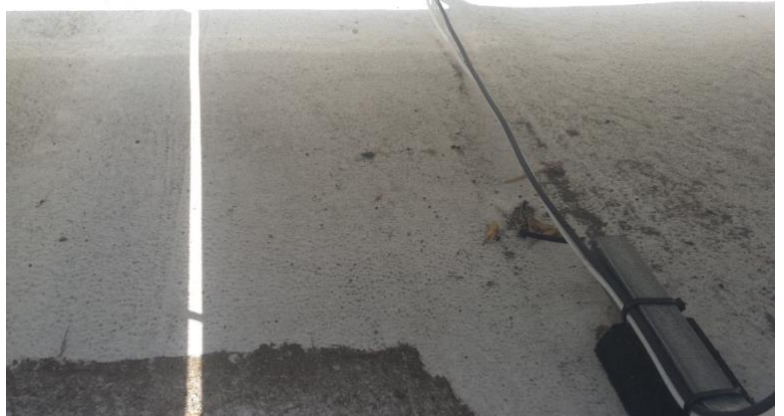
Issue #1

DC wiring is making contact with the roof surface and sharp edges of nearby equipment

NEC 110.3(B) states: "Installation and Use. Listed or labeled equipment shall be installed and used in accordance with any instructions included in the listing or labeling."

Our recommendation:

SepiSolar engineers suggested that the DC conductors throughout the PV system be protected from making direct contact with the roof surface or sharp edges of strut and the like, to prevent abrasion and potential future faults. This is true throughout the entire PV system. In addition, we recommend that the wiring be protected from direct sunlight, in lieu of its UV-resistant rating.

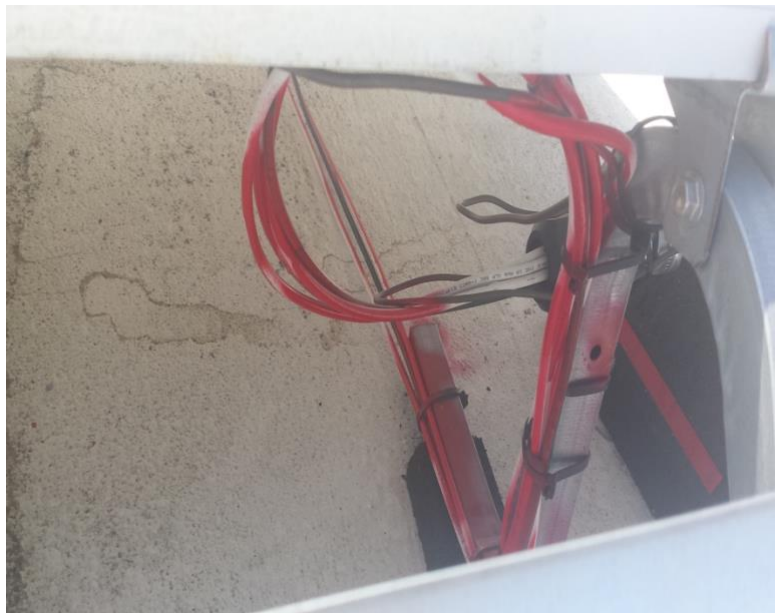
Issue #2

Unapproved means for color coding DC wiring

NEC 210.5(C)(1)(a) states, "Means of Identification. The means of identification shall be permitted to be by separate color coding, marking tape, tagging, or other approved means."

The image appears to show red spray paint used to color-code the DC wiring.

Our recommendation:

Since spray paint is not considered an approved means to identify conductors, we suggest using red electrical tape with 3 continuous stripes along the conductor at 24-inch intervals.

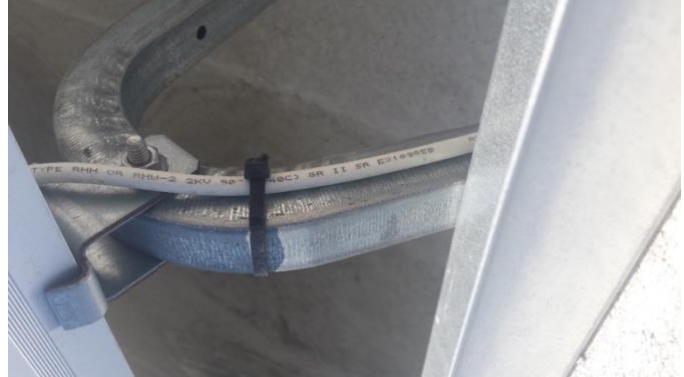
Issue #3

Use of RHW-2 instead of PV Wire for an ungrounded system

NEC 690.35(D) states, “Conductors. The PV source conductors shall consist of the following:

- (1) Metallic or nonmetallic jacketed multiconductor cables
- (2) Conductors installed in raceways
- (3) Conductors listed and identified as PV wire installed as exposed, single conductors, or
- (4) Conductors that are direct-buried and identified for direct-burial use”

Our recommendation:

Since the installed single conductor wires are not listed as PV Wire, SepiSolar recommended that all exposed, single conductors be replaced with PV wire.

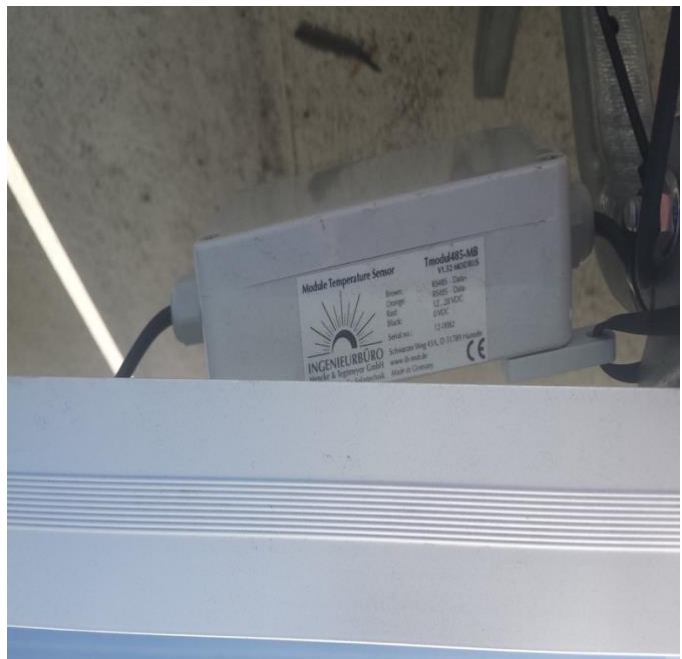
Issue #4

Wire ties not considered an approved means to attach/affix equipment

NEC 110.3(B) states, “Installation and Use. Listed or labeled equipment shall be installed and used in accordance with any instructions included in the listing or labeling.”

The temperature sensor is being held in place only by wire ties, which is not considered an approved means to attach equipment.

Our recommendation:

SepiSolar suggested that the module temperature sensor be secured in place by an approved means in order to withstand the 25-year design life of the system.
